# Fire Risk Assessment

The Griffin,  
125 Clerkenwell Road,  
Farringdon,  
London,  
EC1R 5BD

Date of Assessment: 19<sup>th</sup> January 2017

Prepared by:	Alan Lynagh BSc (Hons)
Company:	ComplianceUK
Date:	19 <sup>th</sup> January 2017
Issue:	1
Report ref:	CUK/FRA/AL/GR/V1

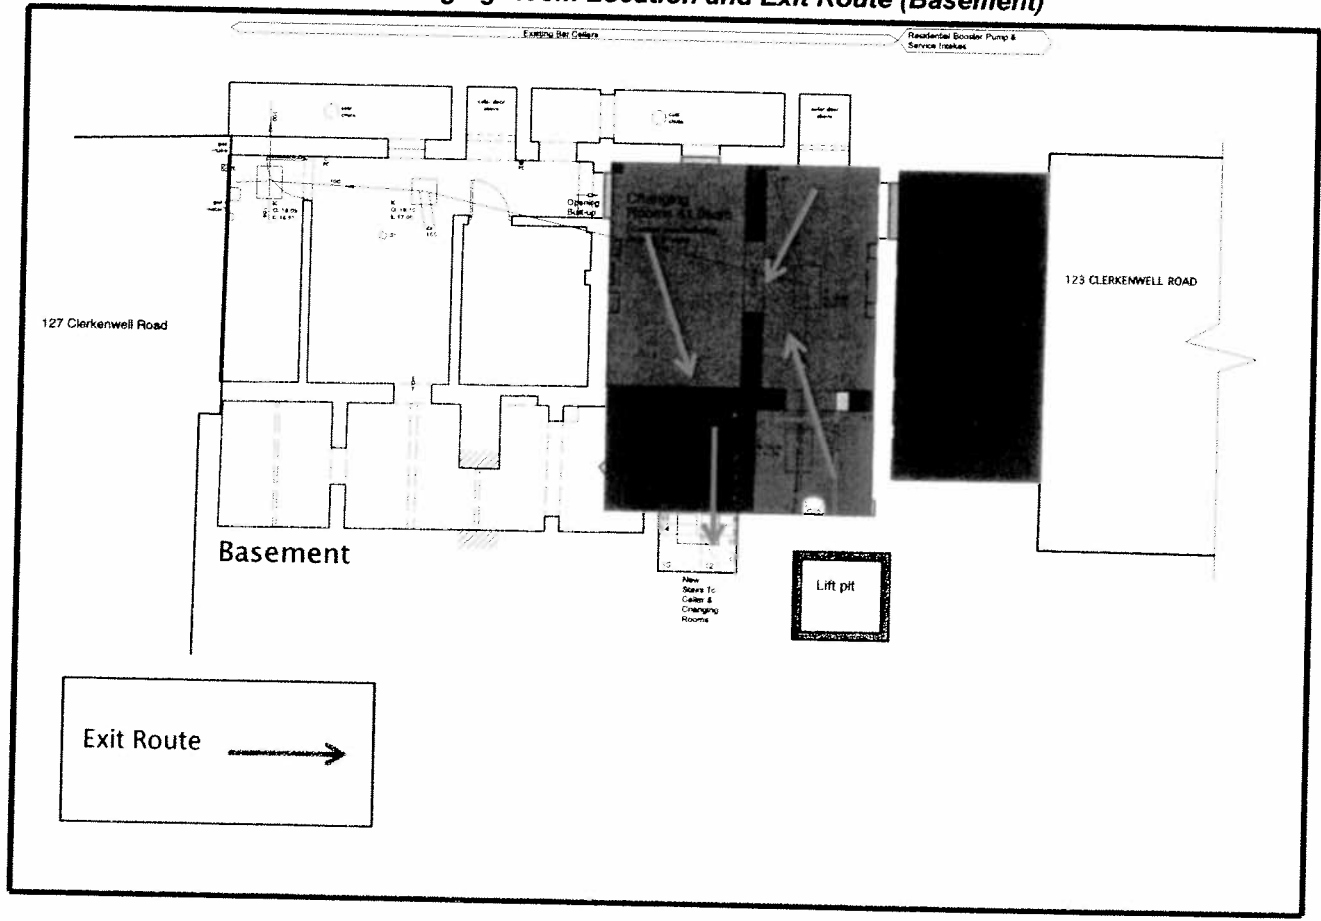
**Fig 17.0: Proposed Female Changing Room Location and Exit Route (Basement)**

Based on these mitigating factors the door width is deemed acceptable. Fig 17.0 and 17.1 details the proposed female changing room location and exit route.

All doors onto the exit route at both basement level and ground floor level will be 30 minute rated fire doors fitted with intumescent strips and smoke seals and the existing fire alarm and detection will be extended as required. It is understood the staircase will be sealed at first floor level to 60 minute fire rated construction. The scheme and the proposed new means of escape are therefore deemed adequate.

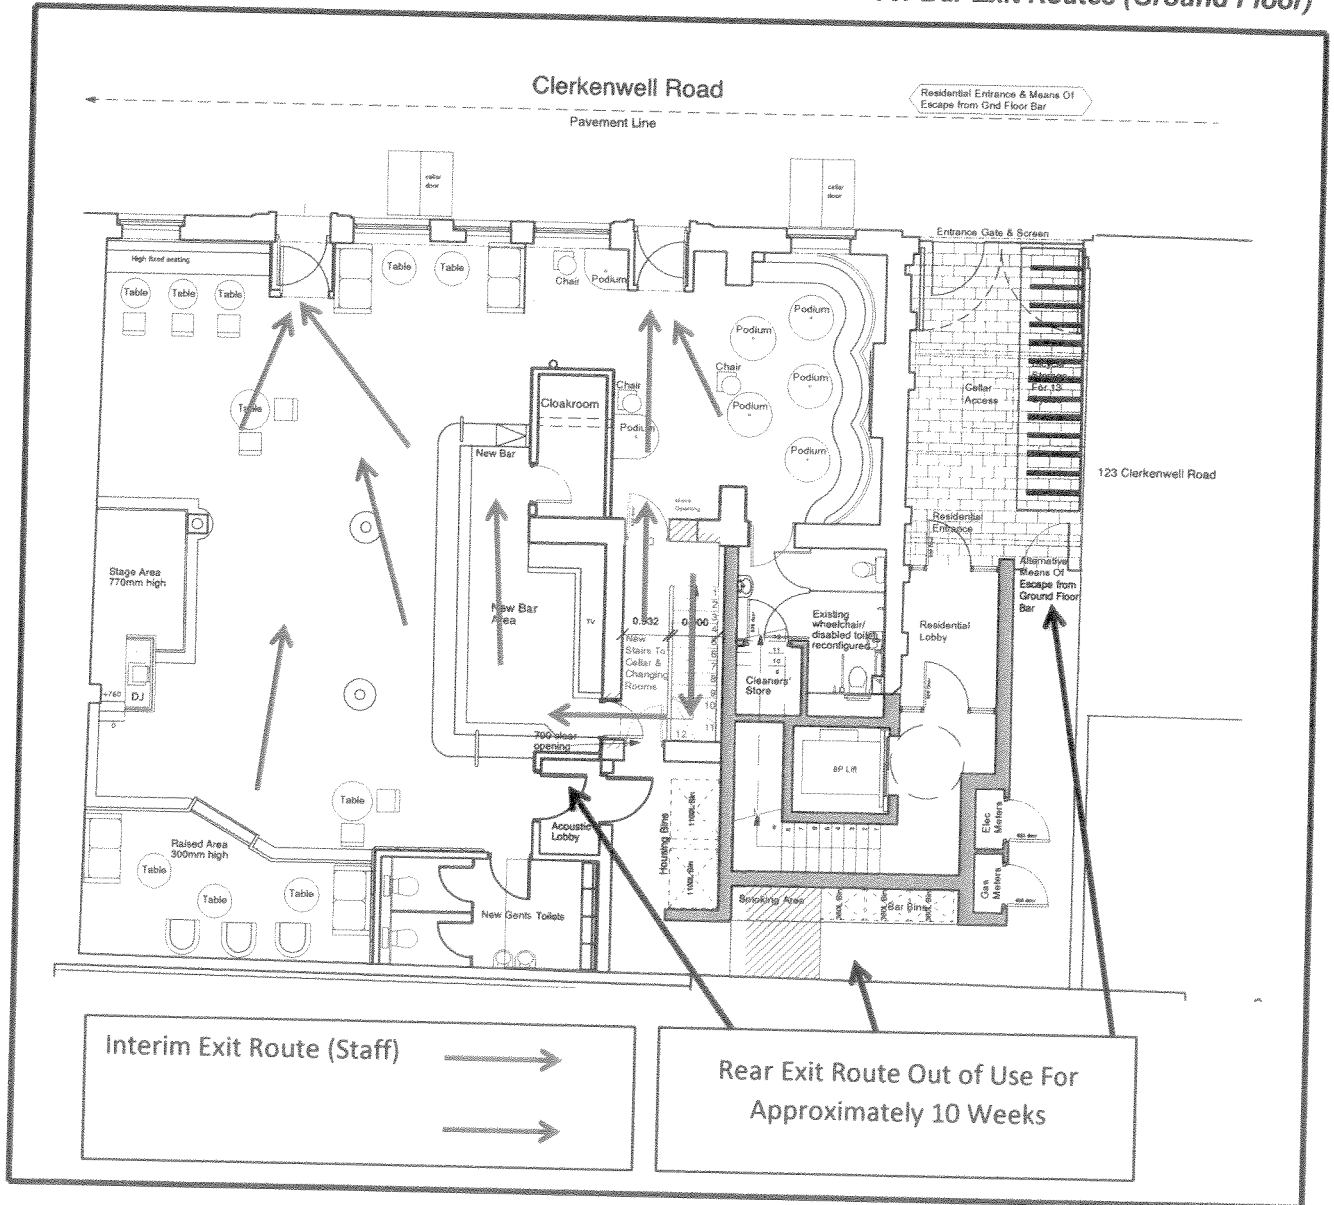
**Fig 17.2: Proposed Interim Female Changing Room and Ground Floor Bar Exit Routes (Ground Floor)**

Fig 17.2 details the proposed interim means of escape arrangements at ground floor level. Fig 17.0 details the basement exit arrangements as these will remain unchanged.

The impact of the interim arrangements at ground floor level is the reduction of three exit routes to two and this may have an impact on the maximum capacity. Table 17.0 details this and the revised capacity.
